## MACHINE SERVICE BULLETIN NO. 358

SUBJECT: Reversals  
LA 5 and LA 6 Models

DATE: July 19, 1940

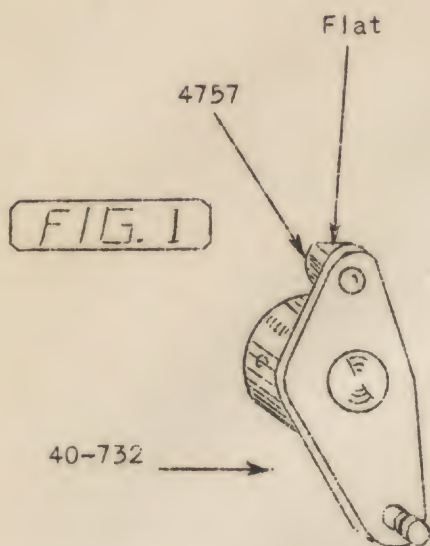
The 4757 stud on the 40-732 and 41-732 crank arm of the carry shaft has a flat side which serves the purpose of retarding the clutch yoke until the proper time for it to move its position from plus to minus or vice versa. See Fig. 1.

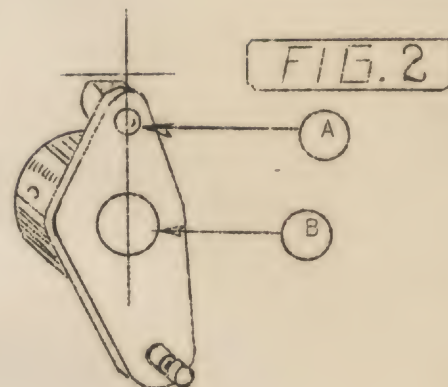
If reversal trouble is encountered, inspect the 40-732 crank arm to determine if the flat of the 4757 stud is located at a right angle to a line drawn through the center of shaft (B) and rivet (A). See Figure 2. If for some reason the flat is positioned otherwise, remove the 40-732 or 41-732 and while held in a vise, turn the stud to the proper position with pliers, after which retighten the rivet or replace the 40-732 or 41-732 with another.

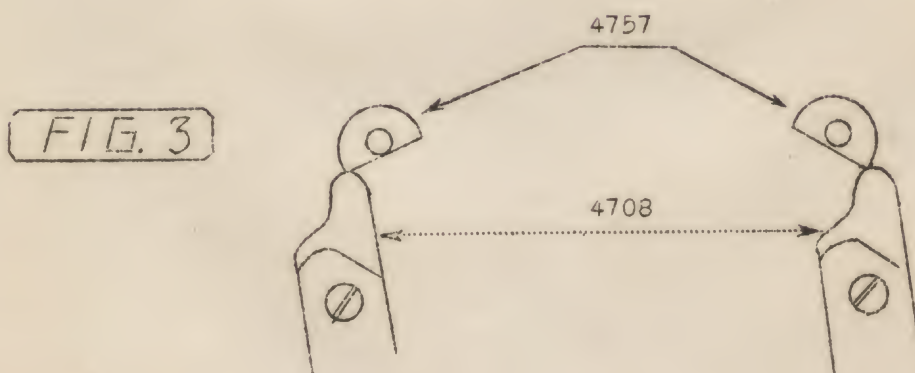
The two edges of this flat side move the clutch yoke into the plus or minus position according to the direction the machine starts to cycle. As the 40-732 or 41-732 turns, the edge of the flat side will contact the center point of the top of the 4708 blank and cause the yoke to move into the position desired (provided the 4708 is correctly adjusted) and the flat of the 4757 stud will prevent movement of the yoke in the wrong direction if it should receive a rebound from some source. See figures 3 and 4.
